Murphy Farms – Little Wabash Site Plan - 120425

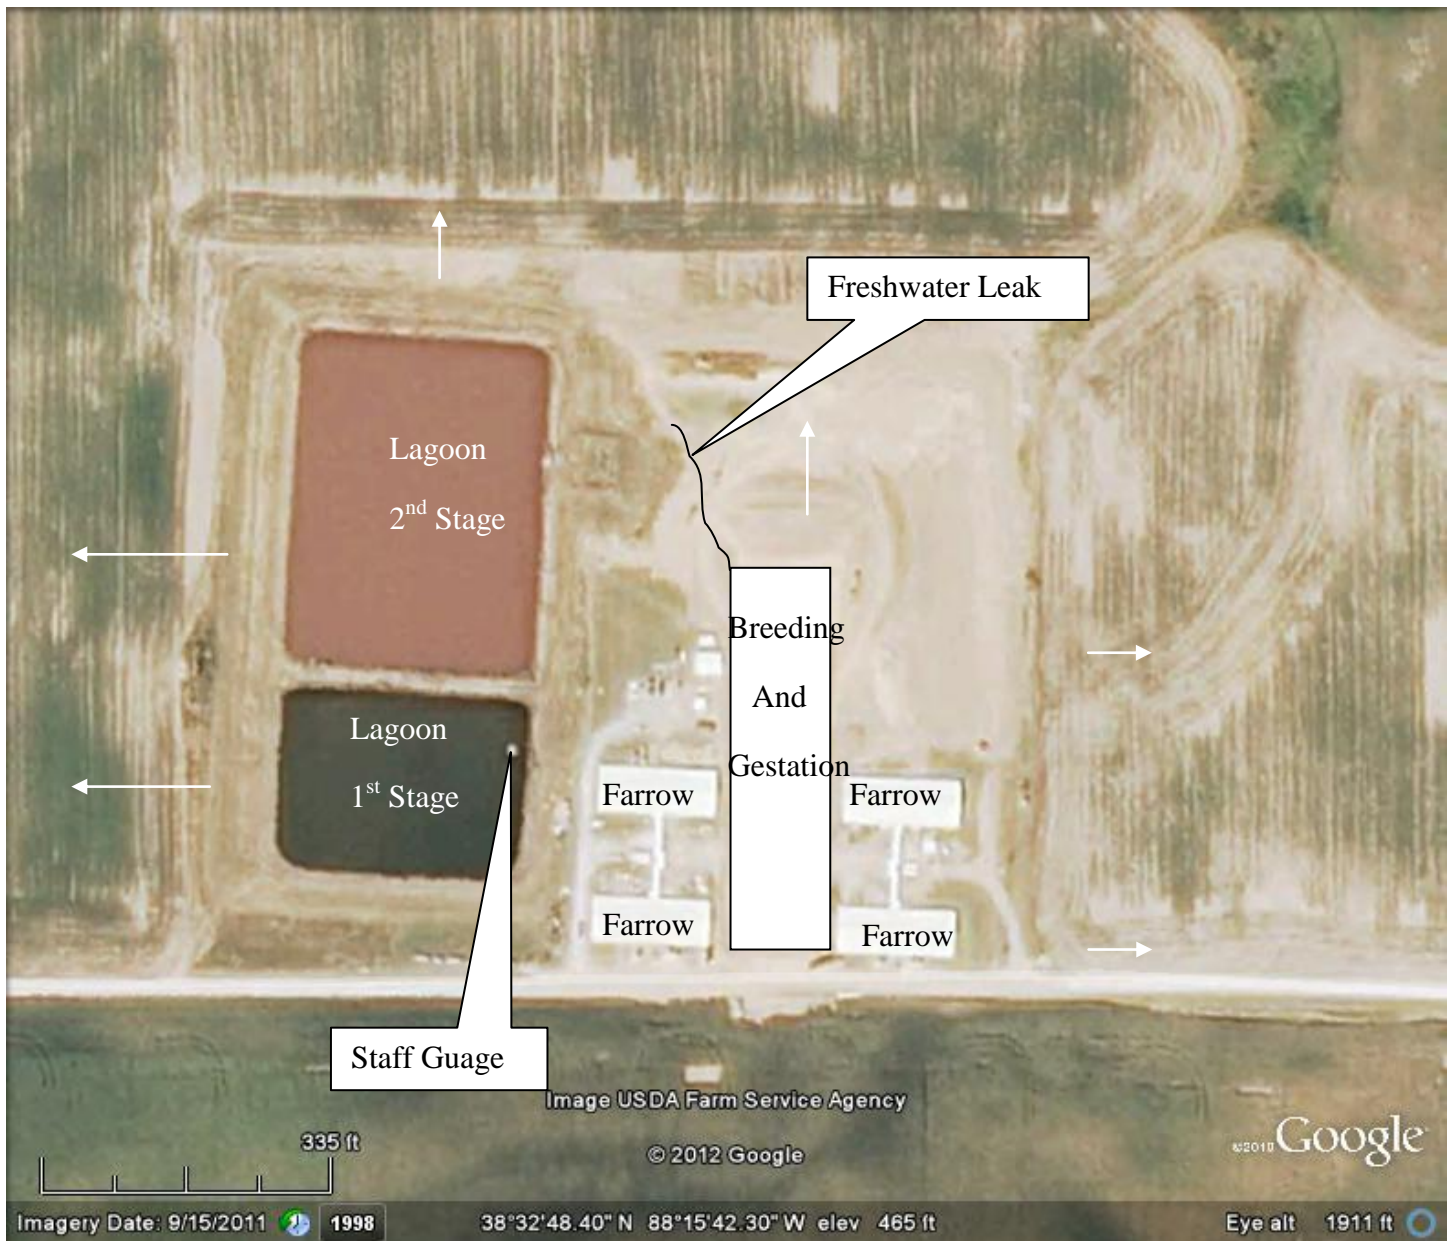
Facility has five (5) confinement buildings and 2-stage lagoon that recharges the shallow pits that are pull plug. The Breeding and Gestation building had a fresh water line leak as shown on the north west corner of the building as the building was newly constructed and the water line was not properly installed.
